PROJECT NUMBER: PAV013-11-07-71766 rev 090106 **DATE:** November 29, 2005
PAGE: 1 of 8

ON-SITE LOAD AND DEFLECTION TESTING OF PAVE EDGING

**PAVE TECH
Attn: Bob Cramer
15354 Flag Avenue South
Prior Lake, MN 55372**

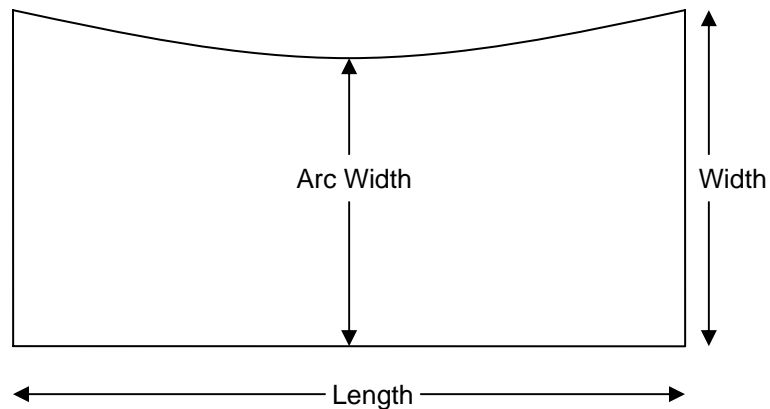
Four (4) test areas were prepared several days before the test date. The test sites were laid out in the following fashion:

All test sites were prepared by Pave Tech. Each shared the same gravel base, and spacing between test areas was approximately two (2) to three (3) feet. Bedding sand was spread in each test area to a thickness of 1 inch. The bed was screeded and the pavers were laid over the sand bed. The pavers used for each test area were Holland Stone pavers measuring 101mm by 202mm by 60mm thick. A soldier pattern of pavers was laid out along the border of the edging, with a herringbone pattern filling in the center sections (see Figure 1). Edging was installed according to the manufacturer's instructions, with spike placement as specified in the charts on the following pages.

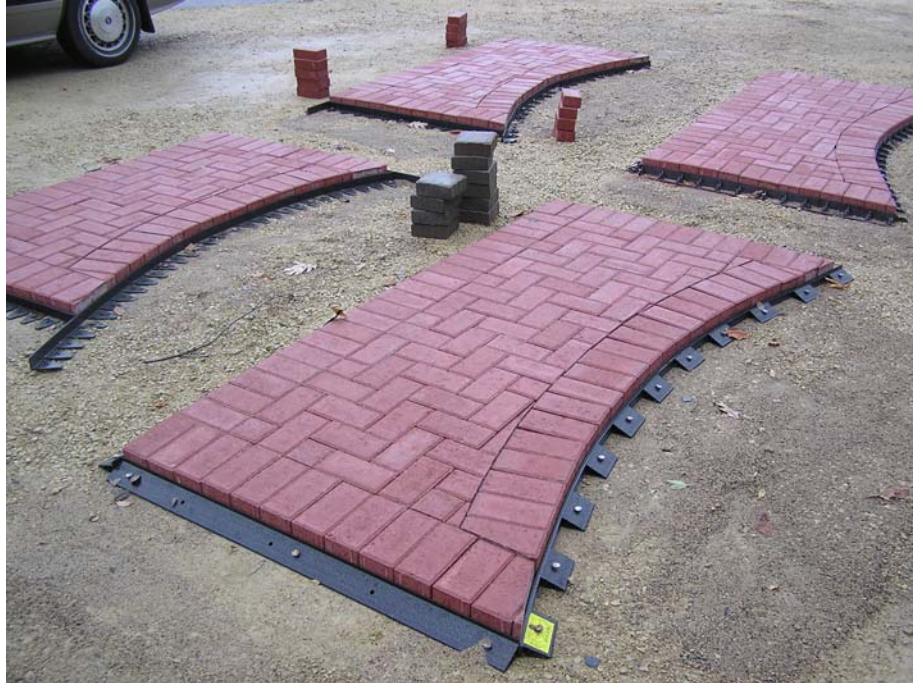
Figure 1--The test areas.

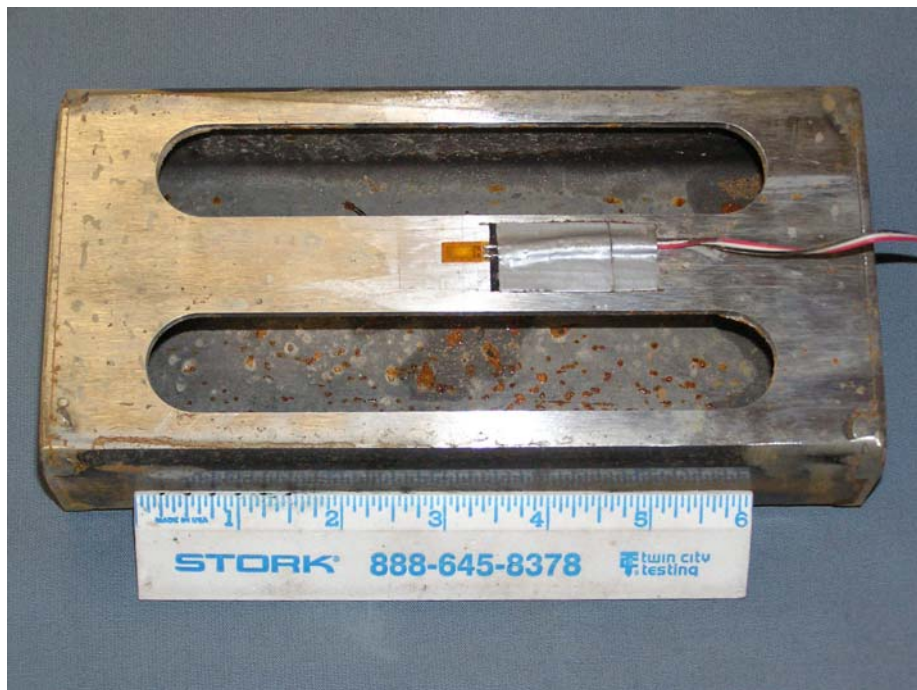
Figure 2--One of the test pavers used to measure the outward force on the edging.

Two (2) test pavers were fabricated out of cold rolled 1045 square steel tubing. They were milled flat on the top and bottom, and steel plate was welded to each end to close the box. Final test paver dimensions were 101mm by 202mm by 45mm thick. A strain gage was attached to each at the center of the top surface. The orientation of the strain gage was parallel to the long direction of the test paver. Two (2) 1-inch slots were milled into the top surface in the long direction. The slots served to isolate the strain gage from transverse forces and to provide better resolution at low loads. A 15mm cover plate was also fabricated to give a final test paver height of 60mm and to protect the strain gage from the compaction process. A photo of the test paver can be seen in Figure 2. Compressive loads were applied to each test paver using a calibrated material test system. Each test paver was calibrated between 10 and 500 pounds. Each paver was soaked at 30 degrees F immediately prior to calibration.

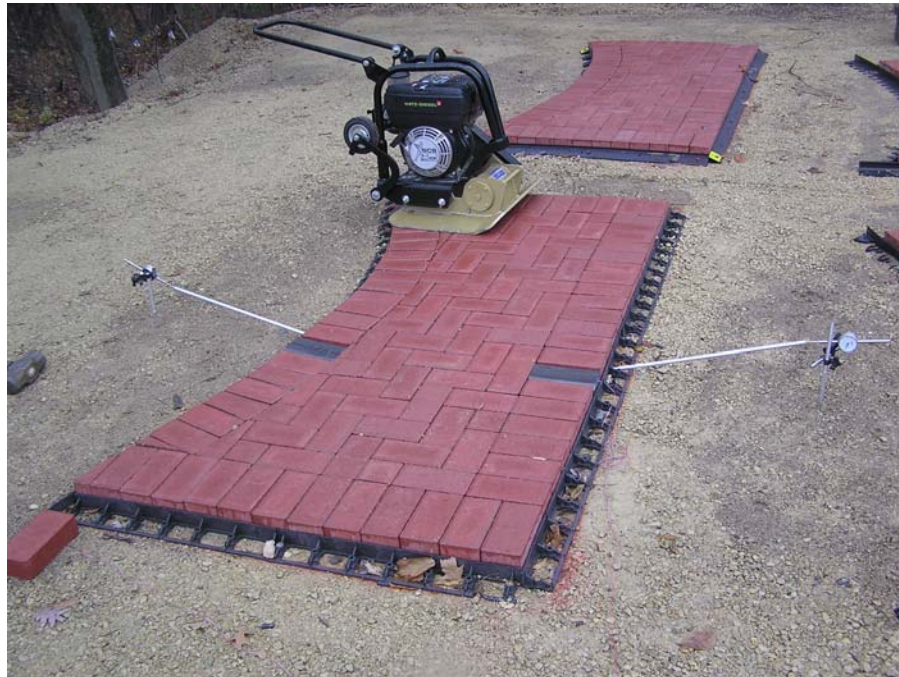
Figure 3--Test and instrumentation setup.

One test area was tested at a time. One paver was removed from a straight soldier border section, and one from a curved soldier border section. Pavers were selected from locations midway between the spikes holding the edging in place. Each was replaced by a test paver connected to a signal conditioner and strain indicator. Two (2) 2-inch dial indicators were used to measure the edging displacement before and after compaction. An aluminum post was driven at least 6 inches into the base gravel approximately two (2) feet from the edging to be measured. A 24 inch aluminum post was used to bridge the distance from the edging to the dial indicator. Deflection locations were selected near the test pavers midway between edging spikes.

Pre-compaction loads and displacements were measured and recorded. Instrumentation setup can be seen in Figure 3.

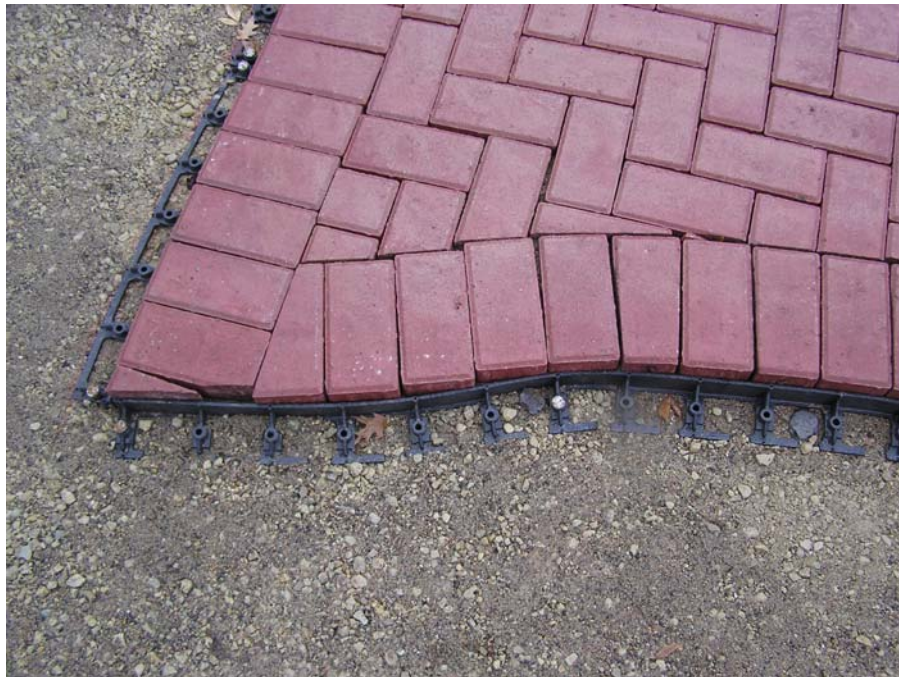
Figure 4—A photo of the Snap Edge curved section after final compaction. Note the large outward deflection. Deflection of this magnitude was common for measurements exceeding 0.200.”
